9) Root Cause Analysis of Mr. Batts Incident via the Scientific Method

11) Examination of the Plaintiff's Expert's Rendered Opinion of Root Cause and Testimony

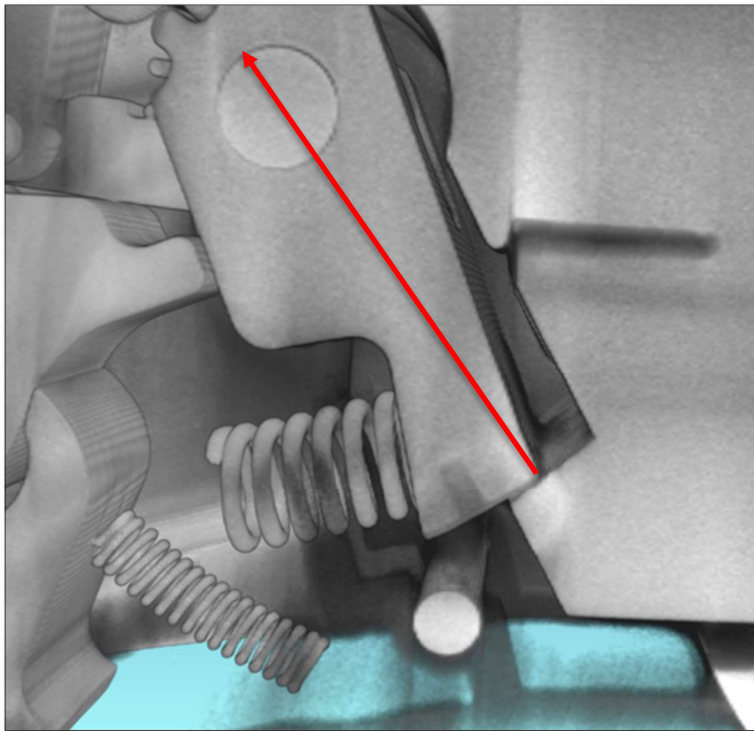
Figure 8.2.4: Contact Vector Between the Barrel Catch and The Barrel Lug

Even though the lockup engagement was under specification, the contact vector between the barrel catch and the barrel lug passed through the center of the barrel catch pivot, positively locking the action. See Figure 8.2.4. When the contact vector runs through the center of the barrel catch pivot, theoretically no amount of contact force can induce an opening torque on the latch. Therefore, if the barrel catch is engaged per the CT scan, the only way to open the barrel via force would require the barrel catch and/or barrel lug to be deformed such that the contact vector was significantly changed, or the two parts no longer engaged one another. No such damage was observed on either part. The lack of damage on the barrel catch and barrel lug indicates the rifle was not locked at the time of the incident.

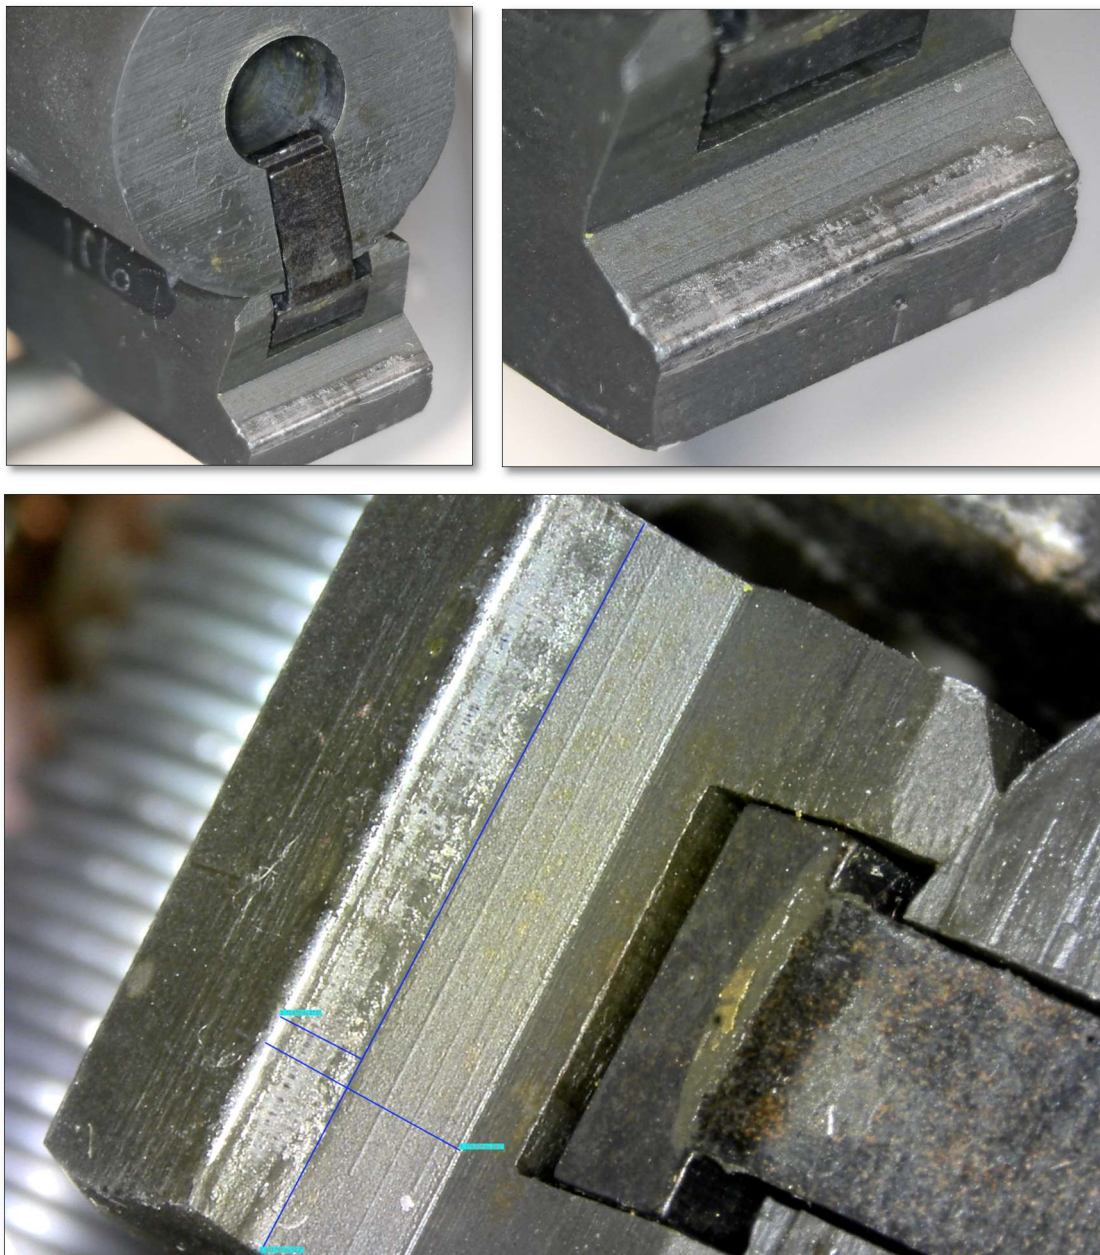
Figure 8.2.5: Engagement Wear Marks on the Barrel Lug

Examination of the barrel lug showed wear marks where the barrel catch had been engaged. As discussed earlier, the barrel catch is curved and the wear marks on the barrel lug represent the contact points between the two components, but not the amount of overlap between the barrel catch and barrel lug. The engagement wear marks were

measured to be approximately 0.074 inches, which is 0.012 inches greater than the measured engagement shown on the CT scan. This means the barrel catch had been engaging the barrel lug to a greater degree at some time before Mr. Powell requested the rifle not be opened and the lockup disturbed before the CT scan. It is unknown if the below specification lockup was staged for the purposes of the CT.

No physical evidence was found to suggest the rifle is defective and dangerous. The engagement measured was more than adequate for the rifle to perform safely and for its intended purpose.

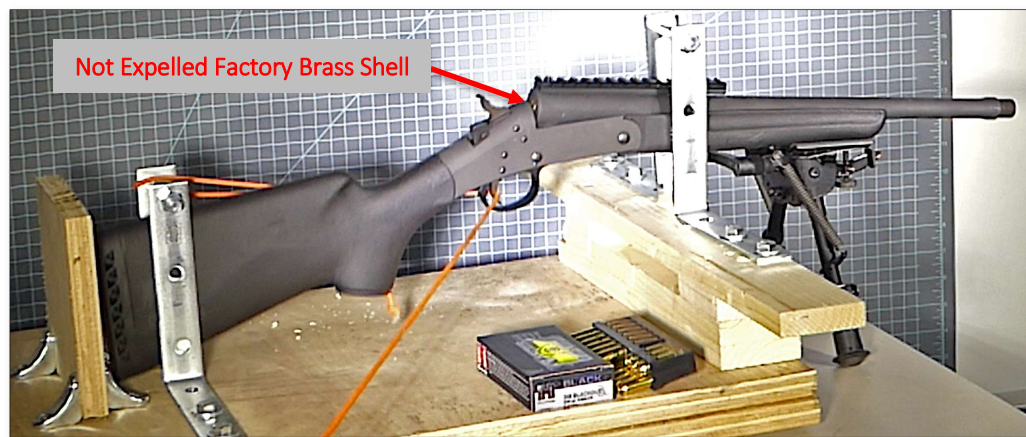
Figure 9.1.1: The Factory Hornady Subsonic 300 Blackout Shell was not Expelled from the Discharged and Unlocked Exemplar H&R Handi-Rifle

lanyard while being constrained from side-to-side, but allowed to open freely. The testing was recorded with standard 1080p video and highspeed video (10,000 and 20,000 fps). See Figure 9.1.1.

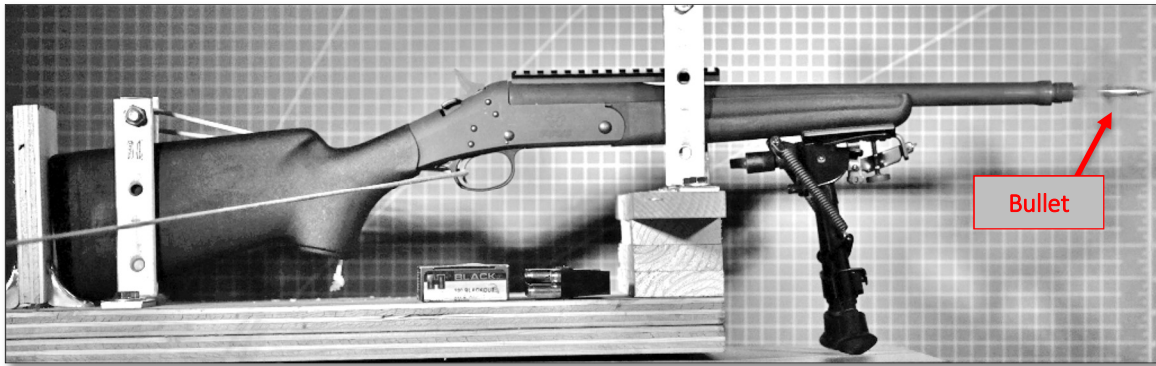
Figure 9.1.3: Factory Hornady Subsonic 300 Blackout Cartridge (208 grain Bullet) Discharged in an Unlocked Exemplar H&R Handy-Rifle

In none of the tests was the discharged shell expelled from the chamber. The highspeed video clearly shows that the action only starts to open well after the bullet has left the barrel and the rifle is recoiling forward after bottoming out the recoil pad. The initial recoil energy drives the rifle straight back and no discernable opening of the action can be observed. The action only begins to open when the rifle recoils forward off the test

fixture's stop. The resulting opening of the action is due to the restoring energy from the test fixture and the recoil pad of the stock. The time between the bullet leaving the barrel and the action opening allows the barrel residual bore pressure to dissipate to a degree that the shell cannot be expelled.

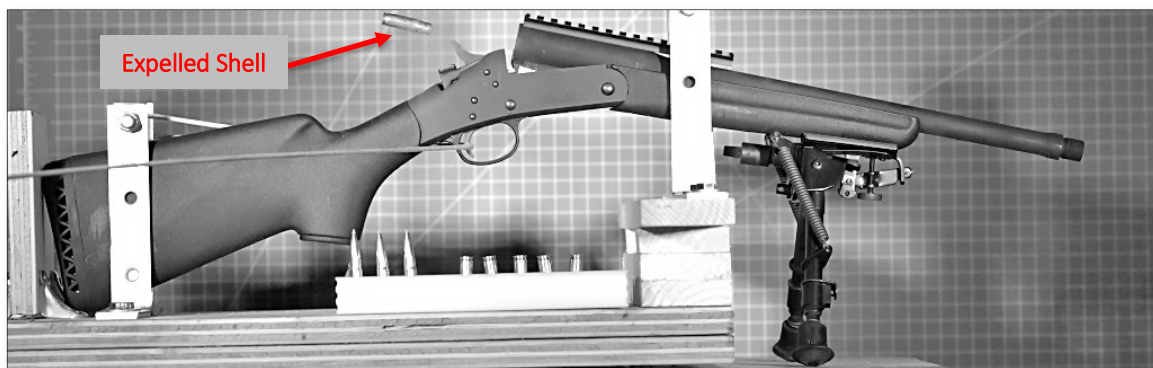
Figure 9.2.2: Highspeed Video Frame of Factory Hornady Subsonic 300 Blackout Ammunition (208 grain bullet) Downloaded to 40% Propellant and Discharged in an Unlocked Exemplar Handi-Rifle.

The bullet did not become lodged in the barrel and the shell expelled from the chamber until the propellant charge was reduced to 40% of the factory charge. This testing showed the bullet must become lodged in the barrel before the pressure produced by the burning propellant will have enough time to force the action open and forcefully expel the discharged shell from the chamber. See Figure 9.2.2. This testing also conclusively proves the order of events with respect to the bullet stopping and the action opening. To produce enough force against the breech face long enough for the action to open, the bullet must lodge in the barrel first. Mr. Powell testified the action was opening and releasing the pressure, which in turn caused the bullet to stop and become lodged in the barrel. Mr. Powell's testimony is directly refuted by this testing.

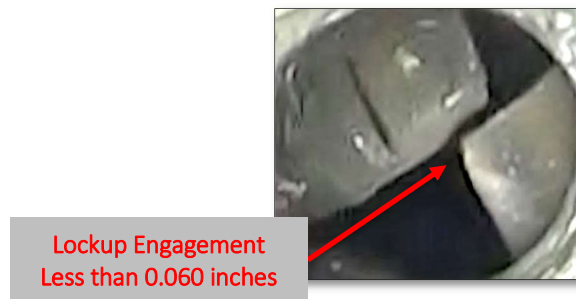
Figure 9.2.3: The Exemplar Test Rifle's Lock Engagement Set Below 0.060 inches.

Thus far, this testing has proven only the first part of my hypothesis. The second part of my hypothesis was that if the action was locked, even partially locked, the shell would not have been expelled after the bullet became lodged in the barrel from the underpowered cartridge. To test this portion of my hypothesis shims were once again employed to adjust the exemplar rifle's lock engagement below 0.060 inches, an engagement below Mr. Powell's claim of engagement at the time of the incident. See Figure 9.2.3.

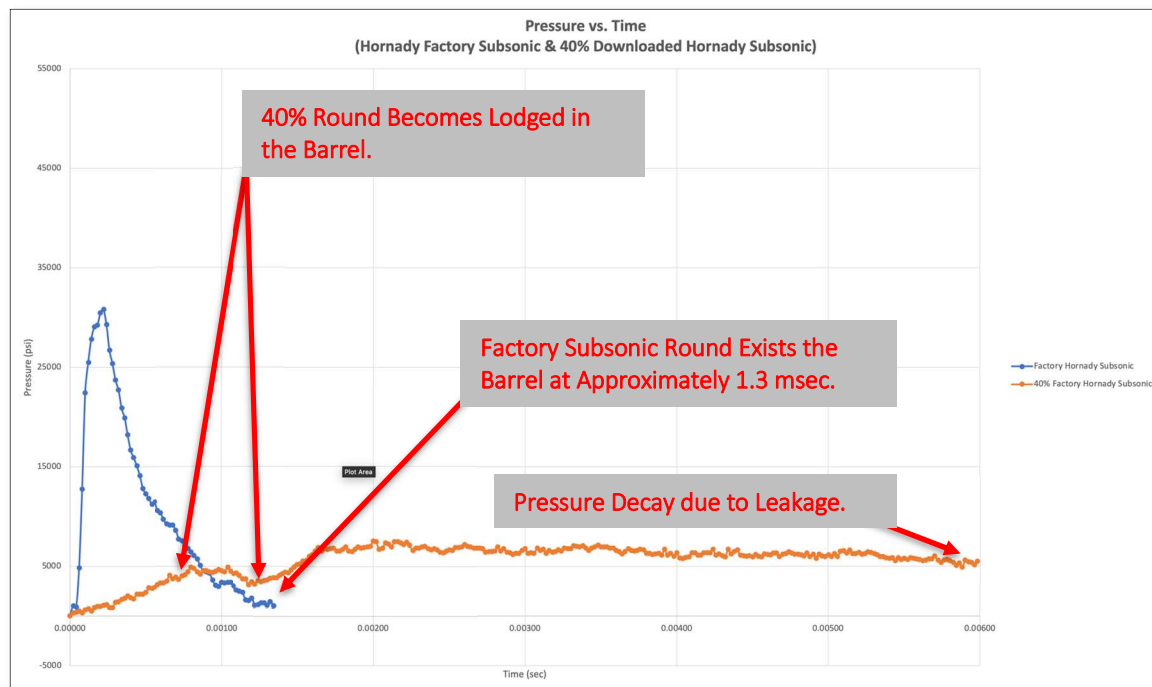
Figure 9.2.5: Pressure vs Time Curves for a Factory Hornady Subsonic 300 Blackout Cartridge and a 40% Downloaded Hornady Subsonic 300 Blackout Cartridge.

to the rifling. When the bullet reaches the end of the rifling, the drag forces are typically at their lowest because the bullet is well shaped. The testing shows the energy required to form a 208 grain 300 Blackout bullet to the rifling and propel it down a 16 inch barrel is greater than a 40% factory Hornady propellant charge can deliver. Mr. Batts was not injured by a SAAMI compliant cartridge of ammunition producing pressures in the 30,000 psi range, but rather by an improperly loaded cartridge producing pressures less than half the measured factory pressure.

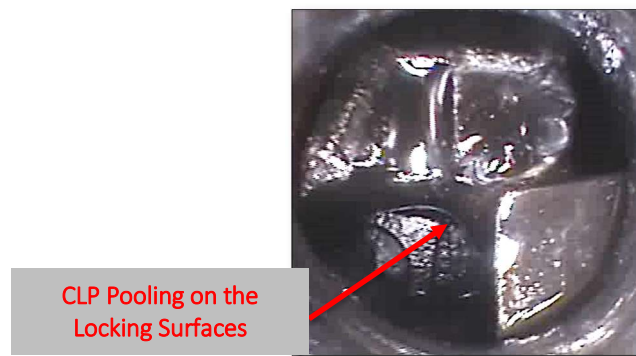
Figure 9.3.2: CLP Lubricated Locking Surfaces

To test the effect adding CLP to the chamber would have on the lockup of a H&R Handi-Rifle, the testing conducted earlier with factory SAAMI compliant 300 Blackout ammunition was conducted again with the chamber of the rifle lubricated with CLP before each shot. See Figure 9.3.1. To maximize the coverage of the CLP, a chamber mop dunked in CLP was used to apply the lubricant to the chamber. Using the chamber mop to apply the lubricant to the chamber had the added effect of lubricating the lockup, which should promote the lockup to unlock if the resulting forces were oriented to do so. See Figure 9.3.2. The testing was conducted with the exemplar rifle unlocked and locked with less than a 0.060 inch engagement. The testing showed that adding CLP to the chamber did not cause the rifle to open when shooting factory SAAMI compliant ammunition.

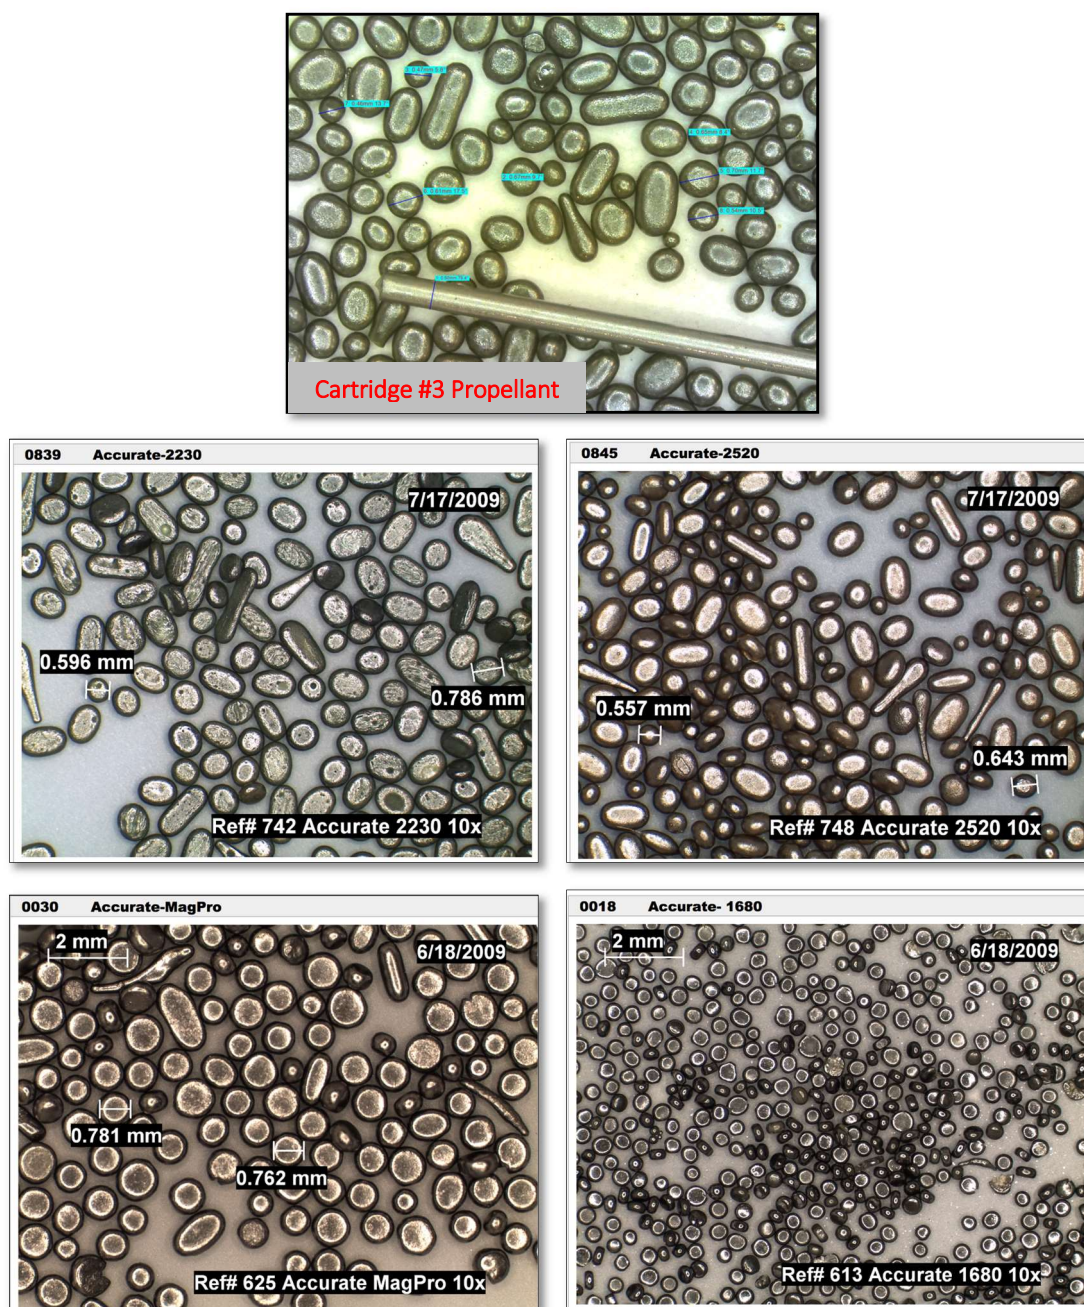
Figure 9.4.2: Propellant Images of Cartridge #3, Accurate 2230, Accurate 2520, Accurate MagPro and Accurate 1680

The National Center for Forensic Science (NCFS) web site has a database of propellants used to load pistol, rifle and shotgun ammunition. By supplying the basic geometry measurements of the propellant taken from Mr. Batts' Cartridge #3, the website provided a list of potential propellant matches. The NCFS search identified 18 propellants that were flattened ball containing oblong granules. See Figure 9.4.1. Narrowing the search with granule width and granule length, three propellants appeared to be the very similar to the Cartridge #3 propellant: Accurate 2230, Accurate 2520 and Accurate MagPro. See Figure 9.4.2.

The Accurate 1680 propellant was included in Figure 9.4.2 to contrast the difference between the propellant observed in Cartridge #3 and an approved 300 Blackout propellant such as Accurate 1680. The Accurate 1680 propellant does not contain the oblong granules observed in Cartridge #3 and the size of the 1680 granules were slightly smaller than the granules observed in Cartridge #3.

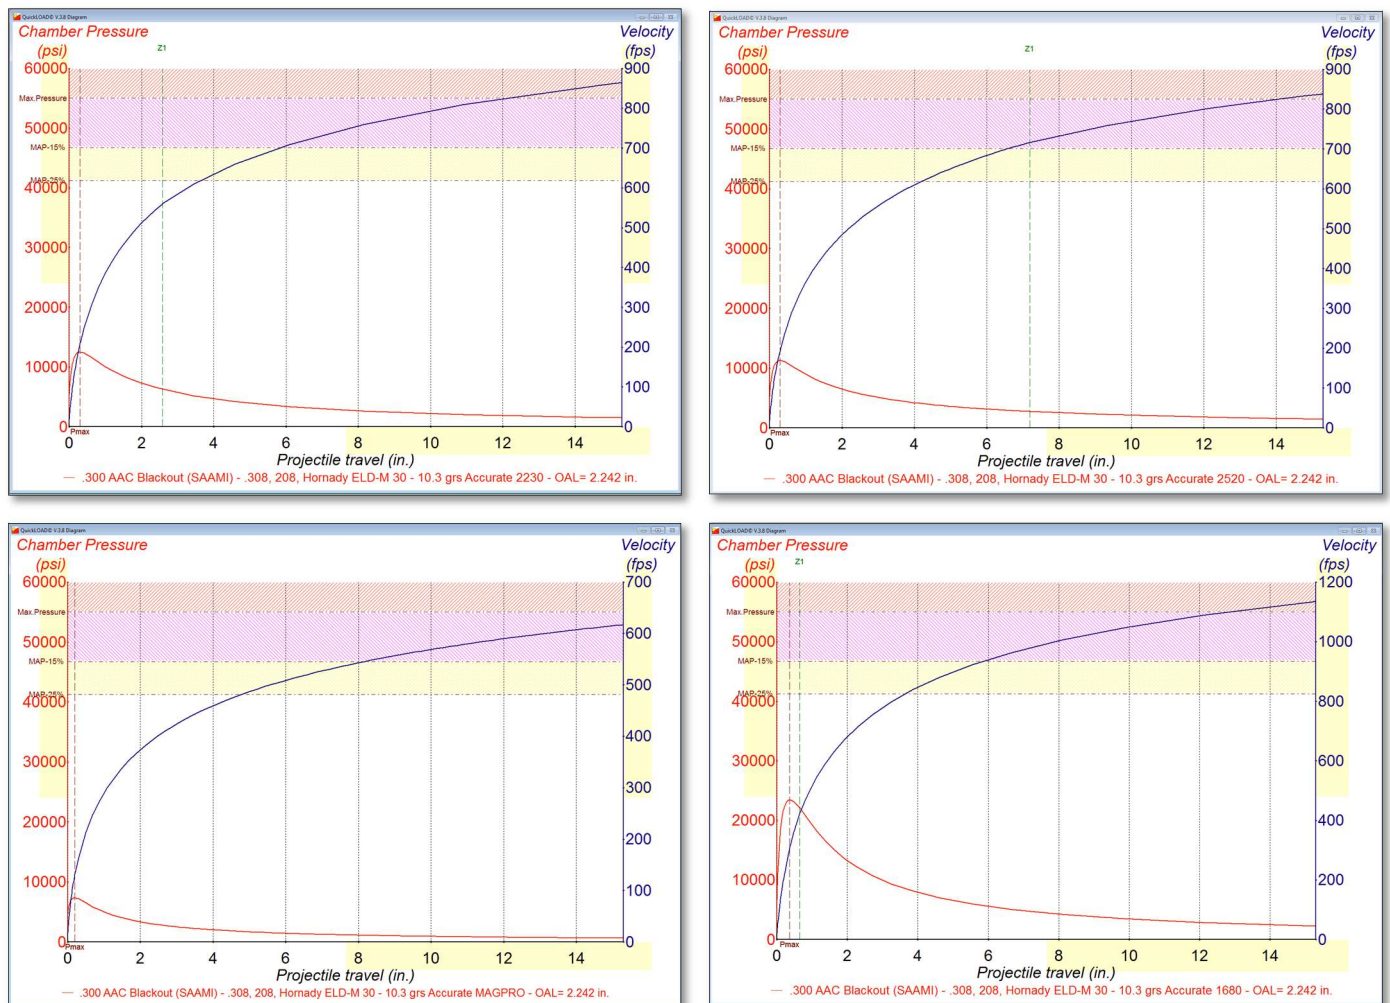
Figure 9.4.3: QuickLoad's Predicted Pressure Characteristics for Accurate 2230, Accurate 2520, Accurate MagPro and Accurate 1680

Hornady's 9th edition *Handbook of Cartridge Reloading* does not recommend loading a 208 grain 300 Blackout subsonic cartridge to produce a max pressure less than 24,000 psi. To analytically investigate the performance characteristics of each of the four identified propellants when loaded into a 300 Blackout cartridge matching Mr. Batts' Cartridge #3 (10.3 grains of propellant, 208 grain Hornady 308 ELD-M Bullet and 2.242 inch COL), QuickLoad was used to simulate the pressure vs. time curve for each propellant. QuickLoad is a commercial interior ballistics program used by most major ammunition manufacturers to aid in ammunition development. Interestingly, each of the non 300 Blackout propellants produced max pressures that were below 13,000 psi and unsafe. See Figure 9.4.3.

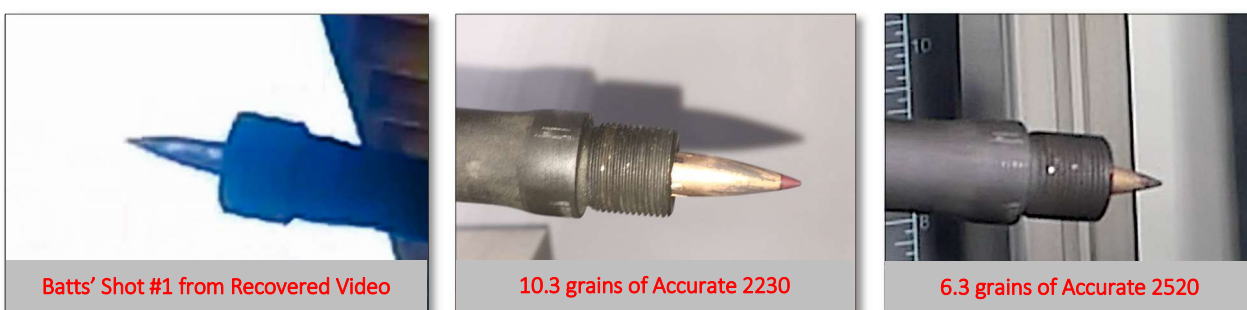
Figure 9.4.5: Mr. Batts' First Squib Load Compared to Squib Loads Produced in Testing.

The deleted video that was recovered from Mr. Batts' GoPro camera (GOPR5587) shows that Mr. Batts experienced a squib load with the bullet lodged at the barrel. During the alternate propellant testing, the 10.3 grain load of Accurate 2230 also lodged a bullet at the muzzle, in a fashion that appears to be identical to Mr. Batts' first squib load. See Figure 9.4.5. While the Accurate 2520 lodged the bullet in the barrel with 10.3 grains of propellant (14.25 inches from the breech face, just shy of the muzzle), 6.3 grain charge of Accurate 2520 lodged the bullet at the muzzle (15 inches from the breech face, protruding from the muzzle). These observed differences in where Accurate 2520 lodged the bullet in the barrel are perfect examples of how the bullet-to-barrel drag forces vary, and how the pressures developed by improperly loaded and under loaded cartridges are unreliable, as warned against by QuickLoad.

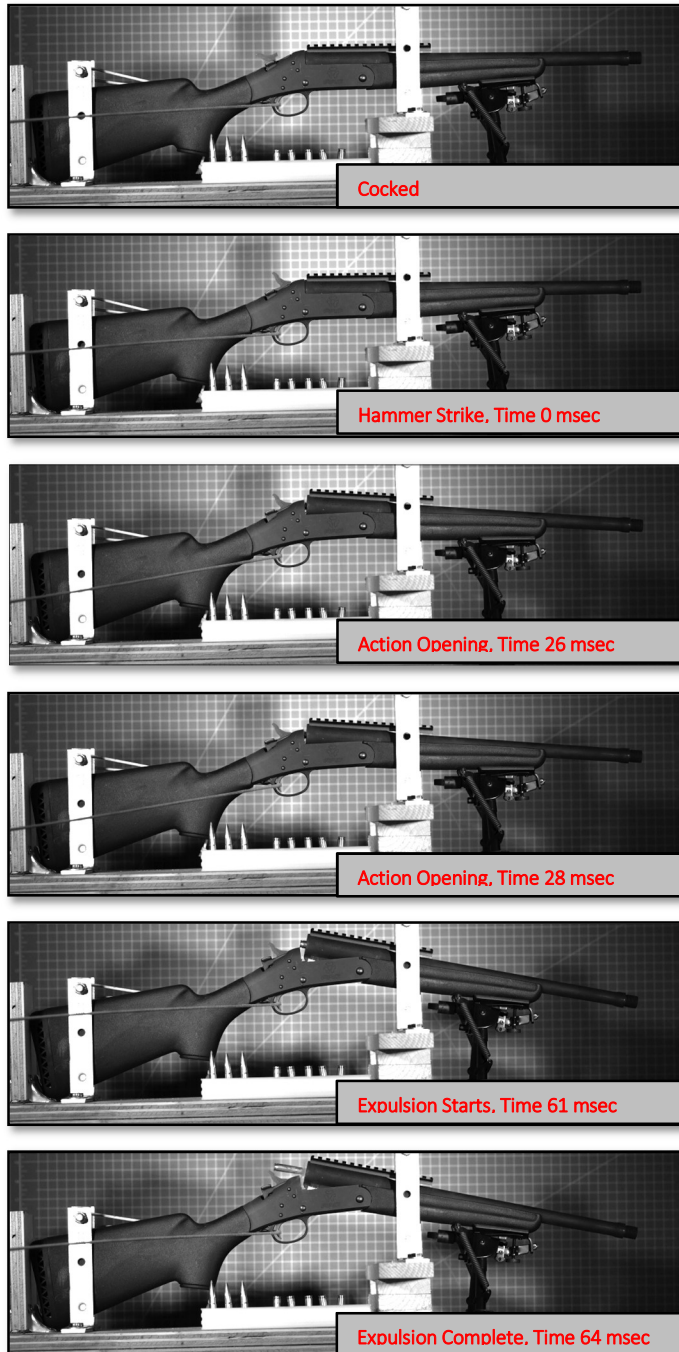
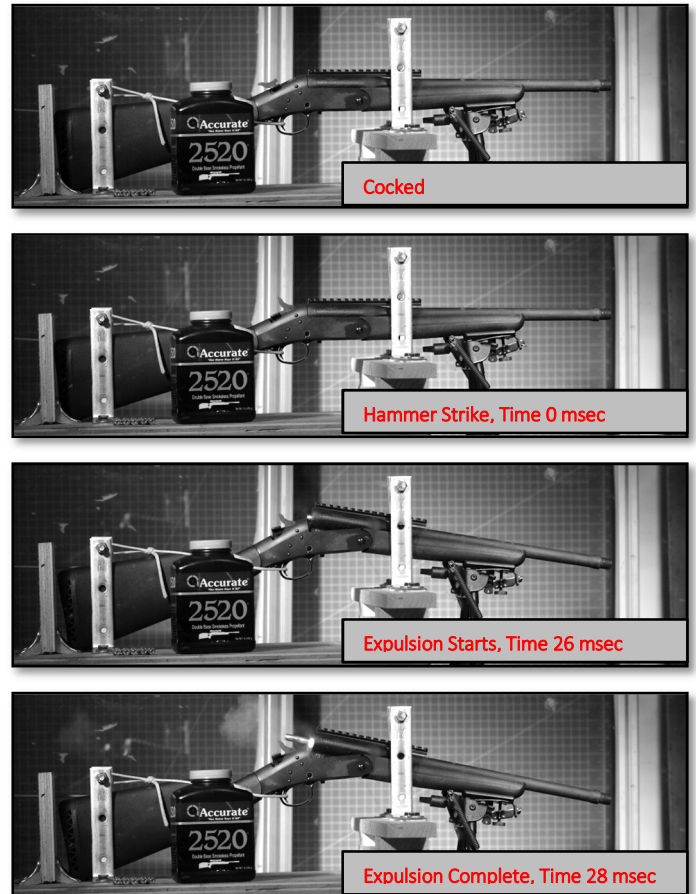
Figure 9.5.1: Shell Expulsion Time vs. Propellant Type

As discussed in section 6, the incident video shows the time elapsed between the hammer hitting the firing pin and the discharged brass being expelled from the rifle as 25 milliseconds (audio analysis). The highspeed video of the live fire testing affords the opportunity to analyze the rate a discharged improperly loaded 300 Blackout shell is expelled from an unlocked H&R Handi-Rifle. Figure 9.5.1 shows a comparison between a

burns faster than the 2520 (a 308 Win Service propellant), which burns faster than the MagPro (a magnum rifle propellant). Typically, the smaller the case capacity, the faster the propellant burns. Subsonic 300 Blackout cartridges have less capacity than 5.56mm NATO cartridges, which have less capacity than 308 Win Service cartridges, which have less case capacity than 300 Win Mag cartridges. To lodge a bullet in the barrel and expel the discharged shell from the rifle's chamber, the underloaded 300 Blackout subsonic propellant took 61 milliseconds, 36 milliseconds longer than Mr. Batts improperly loaded incident cartridge. The improper 308 Win Service propellant (Accurate 2520) took 26 milliseconds to lodge the bullet in the barrel and expel the discharged shell, only 1 millisecond longer than the incident cartridge. The slower burn rate of the Accurate 2520 keeps the pressure up by burning longer. The last highspeed video frame of the Accurate 2520 discharge in Figure 9.5.1 shows the propellant is still burning as the shell is being expelled (flame is coming from the chamber). When the factory Hornady 300 Blackout propellant shell is expelled, no flame can be observed coming from the chamber, indicating that propellant had finished its burn.

This examination of the effect propellant types has on shell expulsion time via highspeed video strongly indicates Mr. Batts' incident 300 Blackout cartridge was not loaded with an improper amount of 300 Blackout propellant, but was rather loaded with an incorrect amount of inappropriate propellant, similar to the 308 Win Service propellant type used in the ammunition Mr. Batts was shooting through his M1A rifle approximately 20 minutes before the incident.

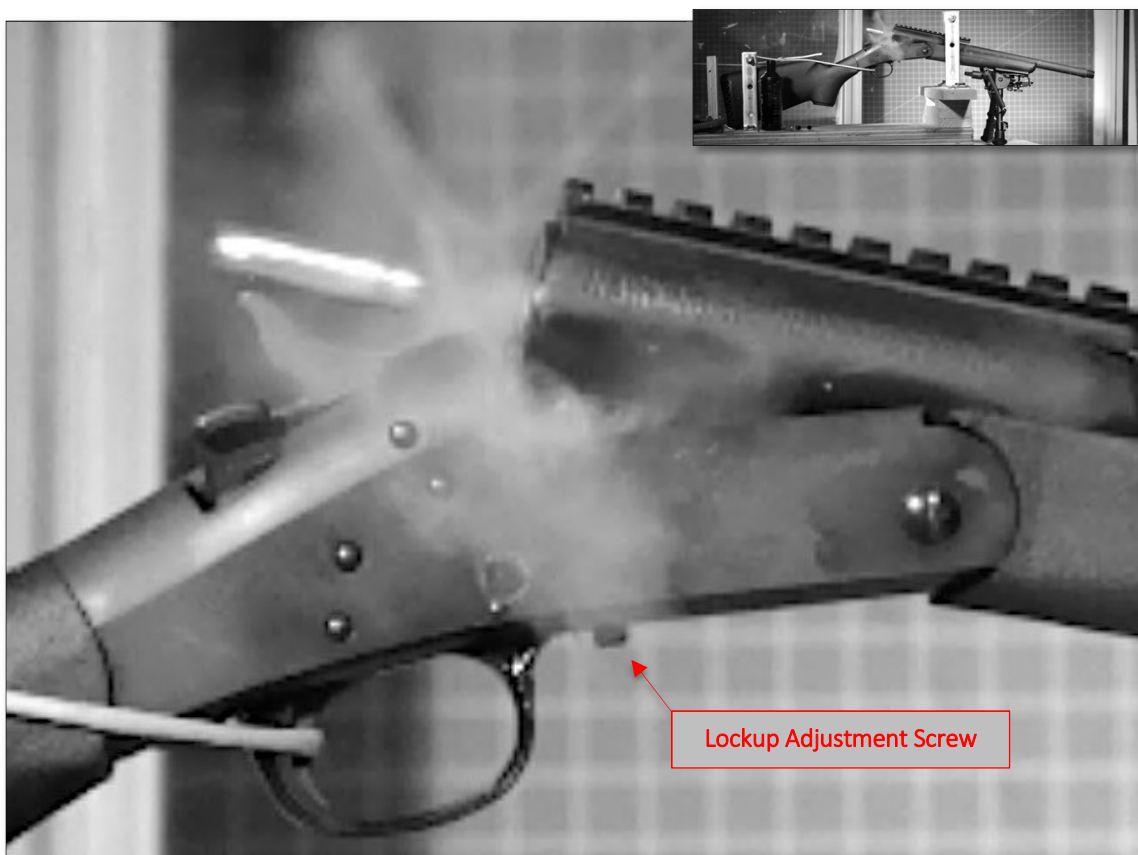
Figure 10.1.2: Incident Reconstruction

To conclusively determine if Mr. Batts incident could have occurred with a locked H&R Handi-Rifle (0.062 inch engagement per Mr. Powell), four test cartridges were loaded with an improper propellant (Accurate MagPro) and the exemplar test rifle was configured with a compromised lockup of less than 0.060 inches. The test rifle was then discharged using the timeline (including the activities such as applying the CLP following the first shot) derived from the GoPro as a guide. The first shot did lodge in the barrel, the second shot did clear the barrel and the third shot did lodge in the barrel. However, because the rifle was partially locked, the action did not open, and the discharged shell was not expelled on the third shot. To fully duplicate Mr. Batts incident, the third shot had to be discharged with the rifle unlocked. See Figure 10.1.2.

To be clear, to reproduce Mr. Batts incident, the first shot was discharged with the rifle partially locked (the bullet lodged in the barrel and the action did not open). The second shot was discharged after the CLP had been added to the chamber and the rifle was partially locked (the bullet cleared the barrel). And, the third shot was discharged with the

rifle unlocked³ (0.000 inch engagement between the barrel catch and barrel lug), which allowed the improper propellant to lodge the bullet in the barrel and the trapped pressure to open the action and expel the discharged shell. When the rifle is locked or partially locked, the trapped pressure cannot force the rifle open and the pressure dissipates through leakage. Therefore, Mr. Batts' incident was caused by Mr. Batts use of improperly formed and improperly loaded non factory Subsonic 300 Blackout ammunition. The improperly formed cartridge prevented the rifle from locking closed and the use of an improper propellant charge prevented the discharged bullet from clearing the barrel.

³ The shims used in the earlier testing to adjust the amount of lockup the rifle could achieve were replaced with an adjustment screw in the receiver and under the barrel lug. See Figure 10.1.2. By turning the screw, the rifle's lockup could be more easily reduced or increased to the desired test level.

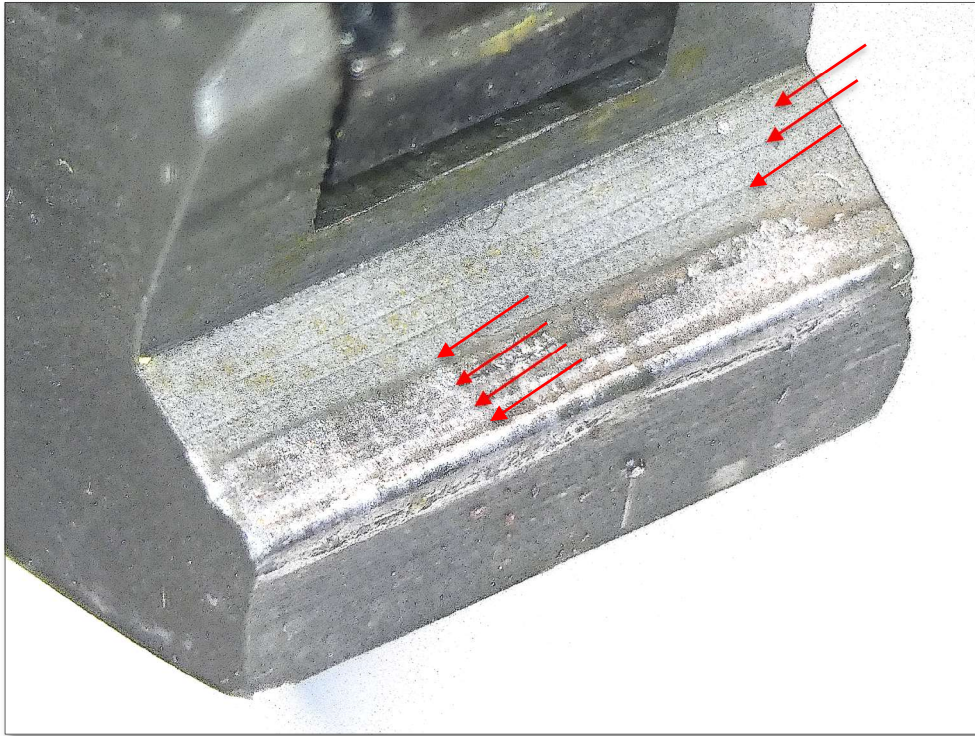
Figure 11.1: Subject Barrel Lug Wear and Machining Marks

Figure 11.1 shows the subject barrel lug. The lug's surfaces show no signs of denting, cracks or alteration. The lug does show signs of contact wear caused by the barrel catch (silver areas), indicating the action had been opened and closed several times. Mr. Powell has stated the barrel lug is damaged and has pointed to the wear areas on the lug. Technically wear is damage, localized disruption of a surface due to repeated contact between two surfaces, but the wear observed will do nothing to alter the mechanical performance of the rifle. Close examination of the barrel lug's engagement surface show linear machining marks running from right to left across the surface (red arrows). The observed breaks in the wear pattern match the machining marks.

For the subject rifle's action to have opened from a locked or partially locked position at the time of the incident, the mechanics of the mechanism would have had to change substantially. Mr. Powell has identified no such demonstrable change and has testified he

cannot identify any specific “damage”/wear which occurred and was caused because of the incident. See Testimony Page 173.

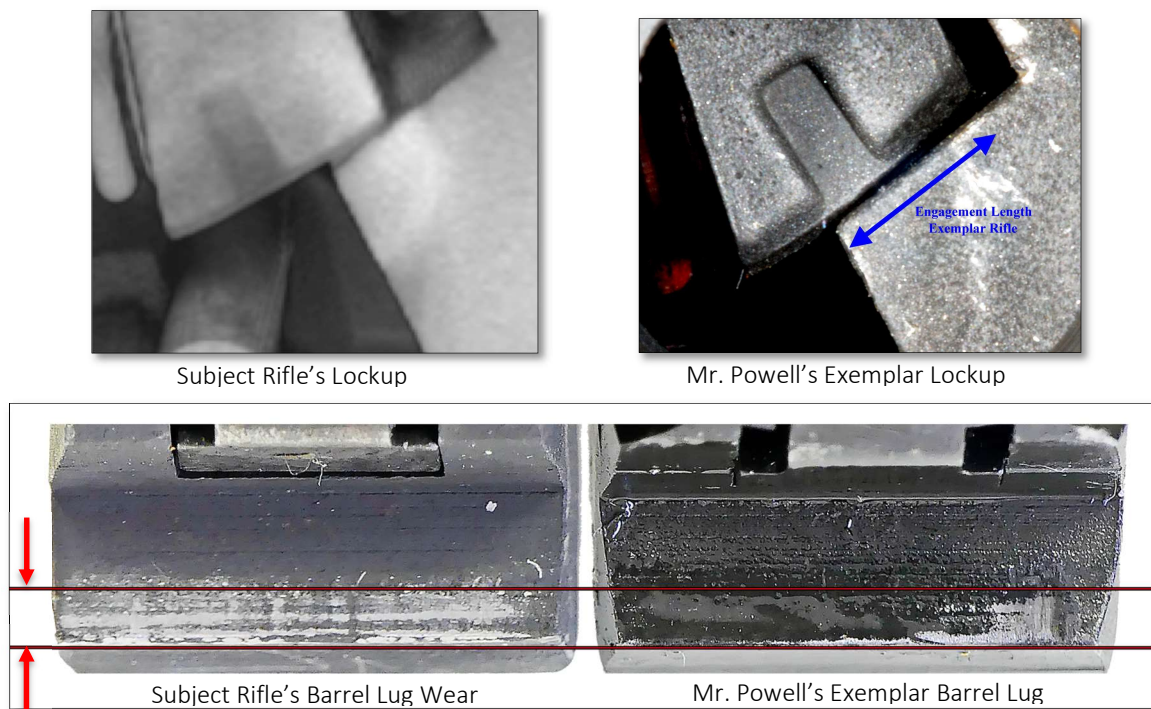
Figure 11.2: Dept of Barrel Lug Wear Compared

Identifying the root cause of mechanical failure requires a fundamental understanding of how the mechanism works to properly identify abnormalities. Mr. Powell testified the wear marks on the barrel lug indicated a defect because they were not "deep" enough. See Testimony Page 176. As discussed in Section 5, the depth of contact between the barrel catch and the barrel lug does not linearly correlate with the amount of overlap between the barrel catch and the barrel lug. Mr. Powell tested an exemplar rifle with the maximum "GO" engagement. However, the depth of wear marks on the exemplar's barrel lug are no deeper than the subject rifle's barrel lug. See Figure 11.2. Close examination of Mr. Powell's exemplar barrel lug wear shows not only the wear mark depth is equivalent to the subject barrel lug's, but also shows the contact was primarily being made of the right side of the lug. Taken as a whole, the exemplar rifle had less locking engagement than the subject rifle yet did not open in any of Mr. Powell's thrust force measurement firings. Science is founded on consistent and repeatable results. If the depth of engagement is a factor in an H&R Handi-Rifle blowing open during discharge, the subject rifle and Mr. Powell's appear to be equivalent in this regard
